Energy

BULLETIN

Office of **ENERGY WA**

Technical & Safety Division

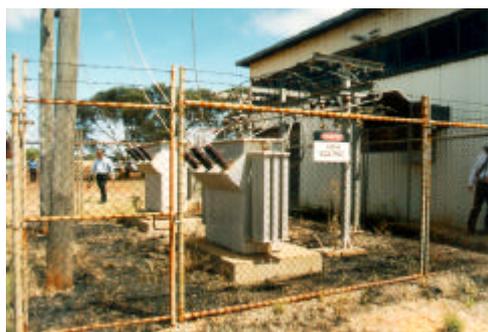
The young engineer apparently walked into the arcing horn of a high voltage bushing on the live transformer and received a severe electric shock. He was thrown to the ground and badly burned in a resulting intense fire in long grass within the transformer compound. He subsequently died from injuries received from the electric shock and the burns.

Investigations revealed that the transformer compound had been built around 1971 and did not comply with the current Australian Standard AS 2067 - 1984 which, amongst other things, defines safety clearances to any exposed live equipment. The incident highlighted the need for all utilities and HV installation owners to ensure that such hazardous installations are brought up to current standards. Furthermore, until such hazardous installations are brought up to current safety standards, it is recommended that access to them must be completely denied unless they are made safe by isolation and earthing of live conductors before entry. It is essential that there is also clear signage at entry points and regular warnings advising all field personnel of the dangers and emphasising the need to wear proper safety gear within substations.

Transformer compound at Ladyloch Pumping Station

It is recommended that all installations with open bushing transformers are checked to ensure that they meet current standards and

that appropriate action is taken where necessary, to ensure the safety of personnel.
